Arthroscopic Partial Lateral Meniscectomy

John A. Schlechter, DO, FAOAO

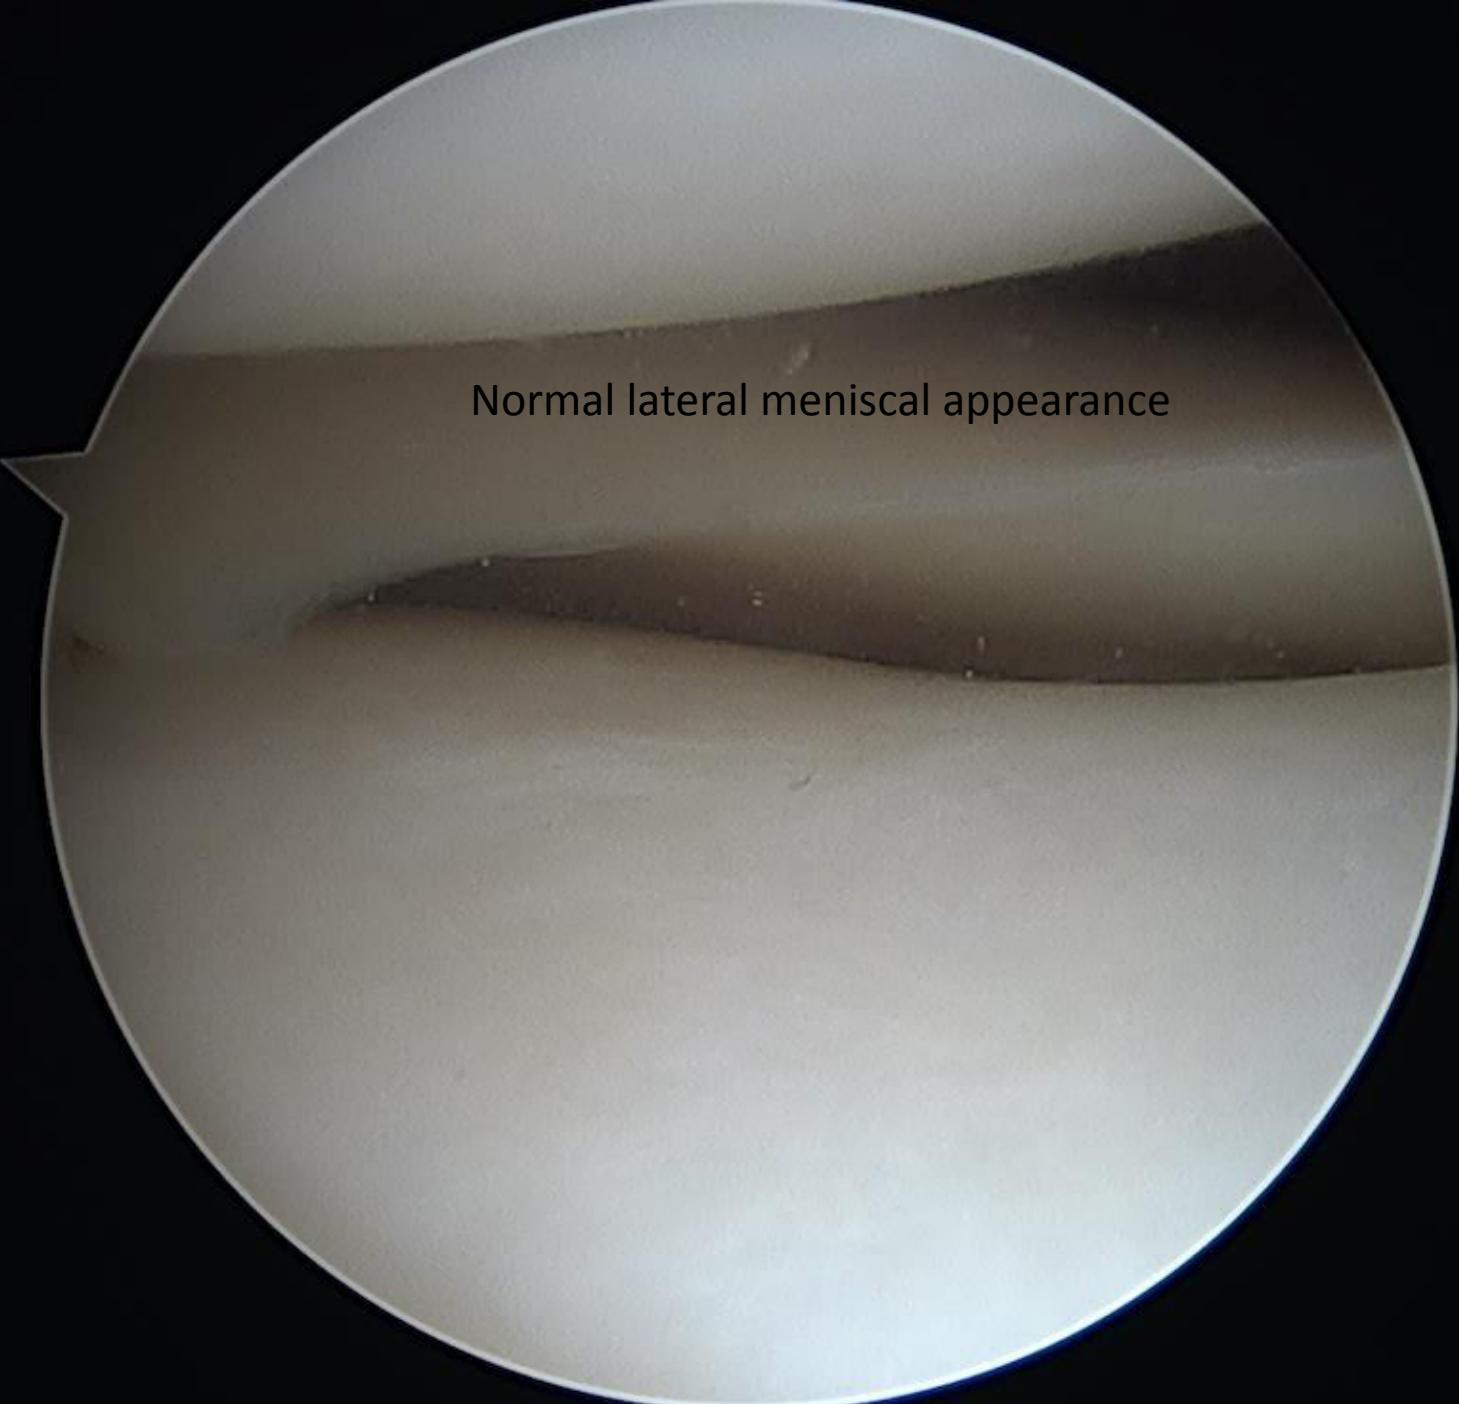
Normal lateral meniscal appearance

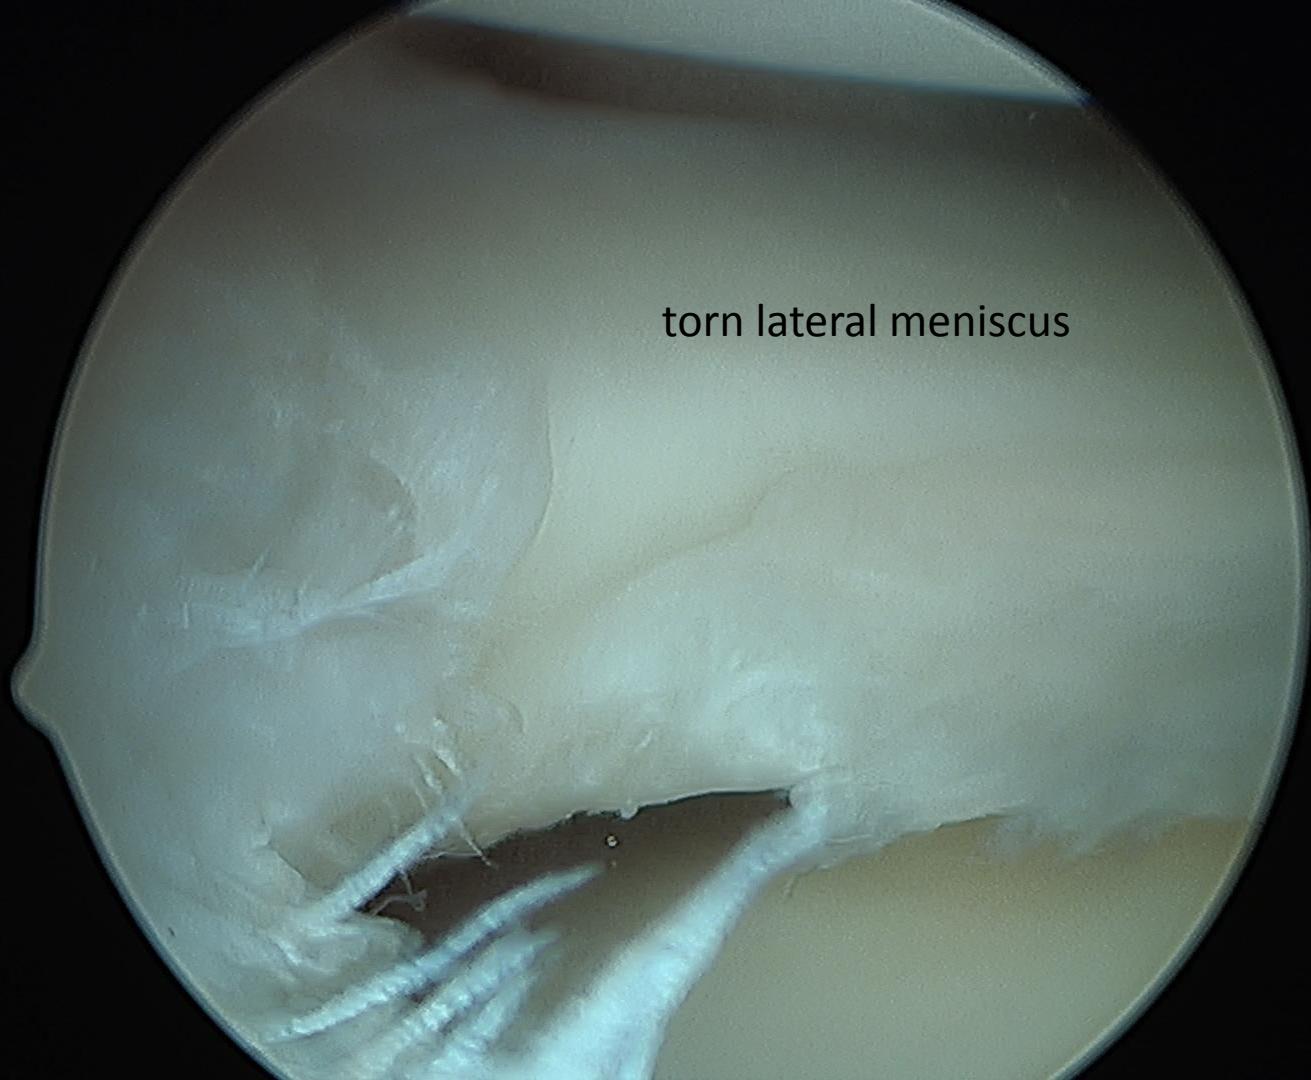
torn lateral meniscus

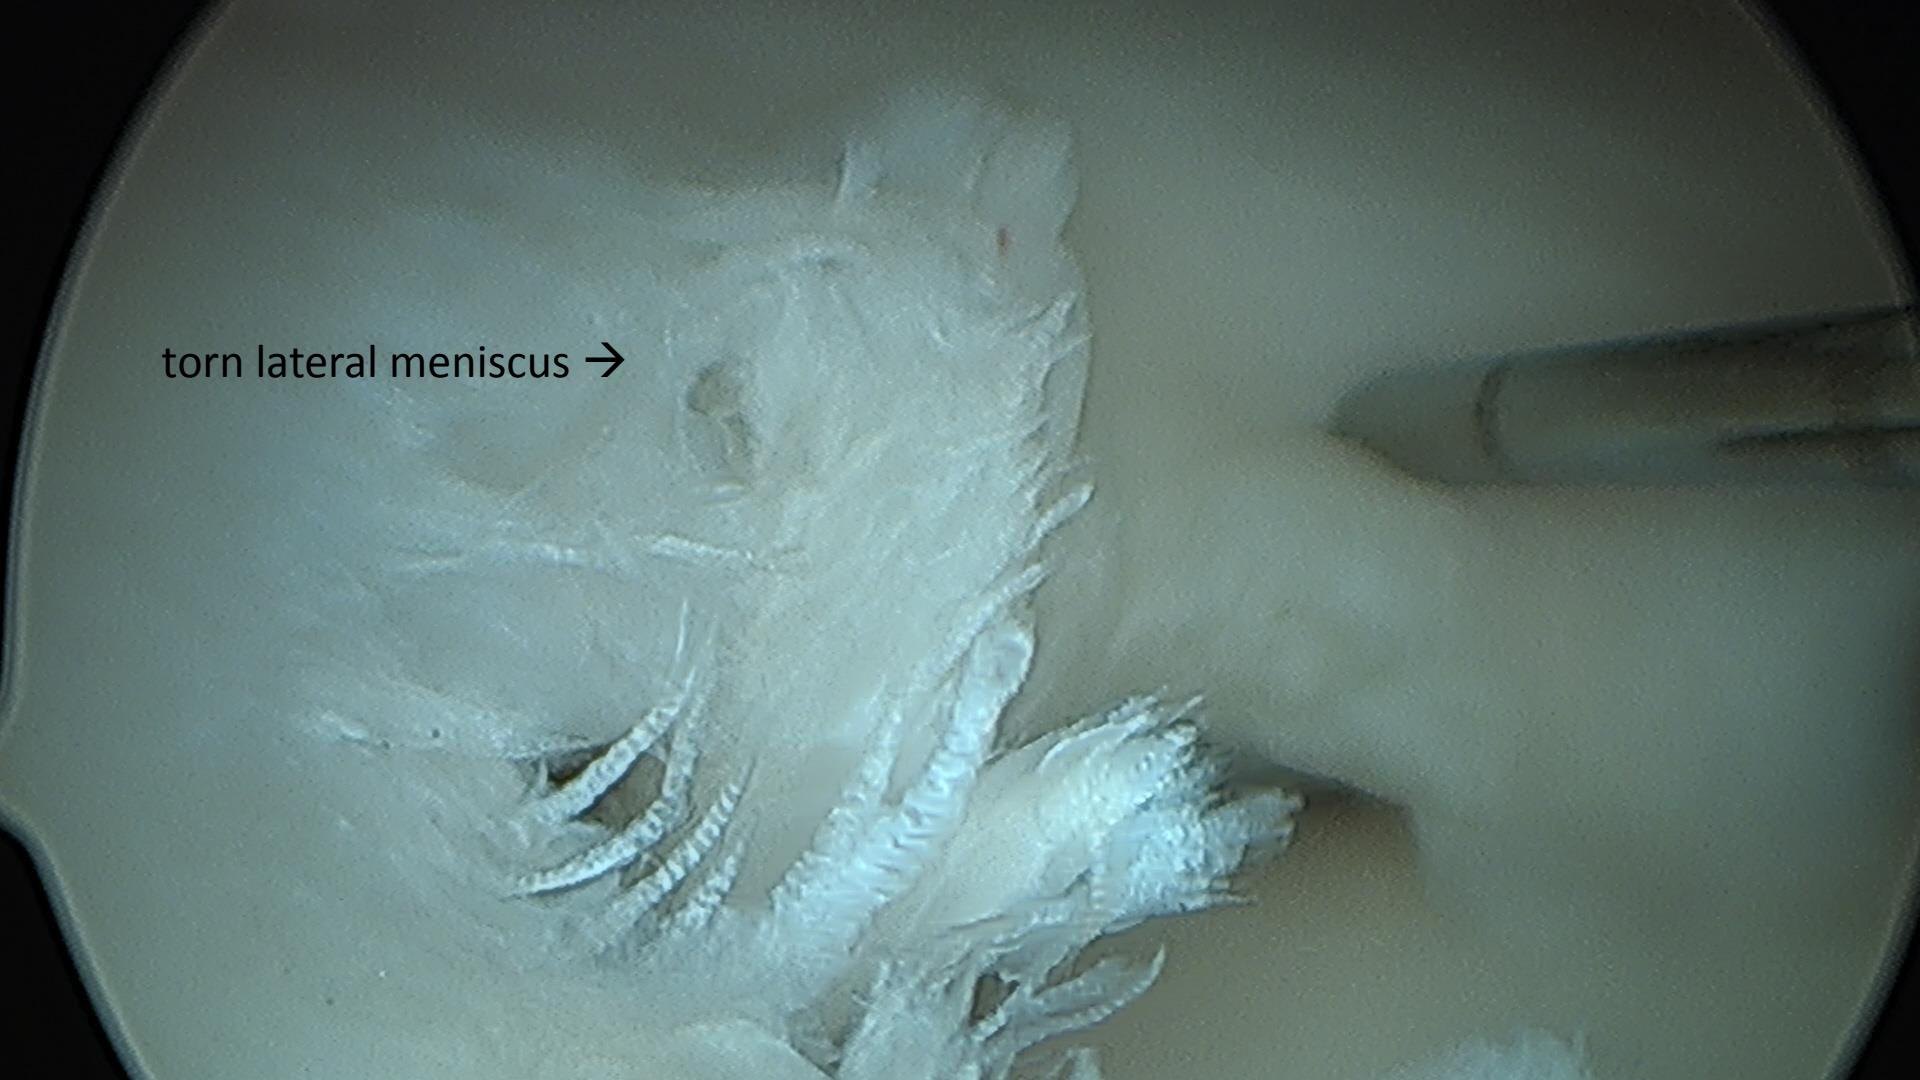
torn lateral meniscus →

A grayscale MRI scan of a knee joint. The image shows the femur and tibia bones. A torn lateral meniscus is visible as a dark, irregular tear in the cartilage between the two bones. The surrounding tissue and muscles appear relatively normal.

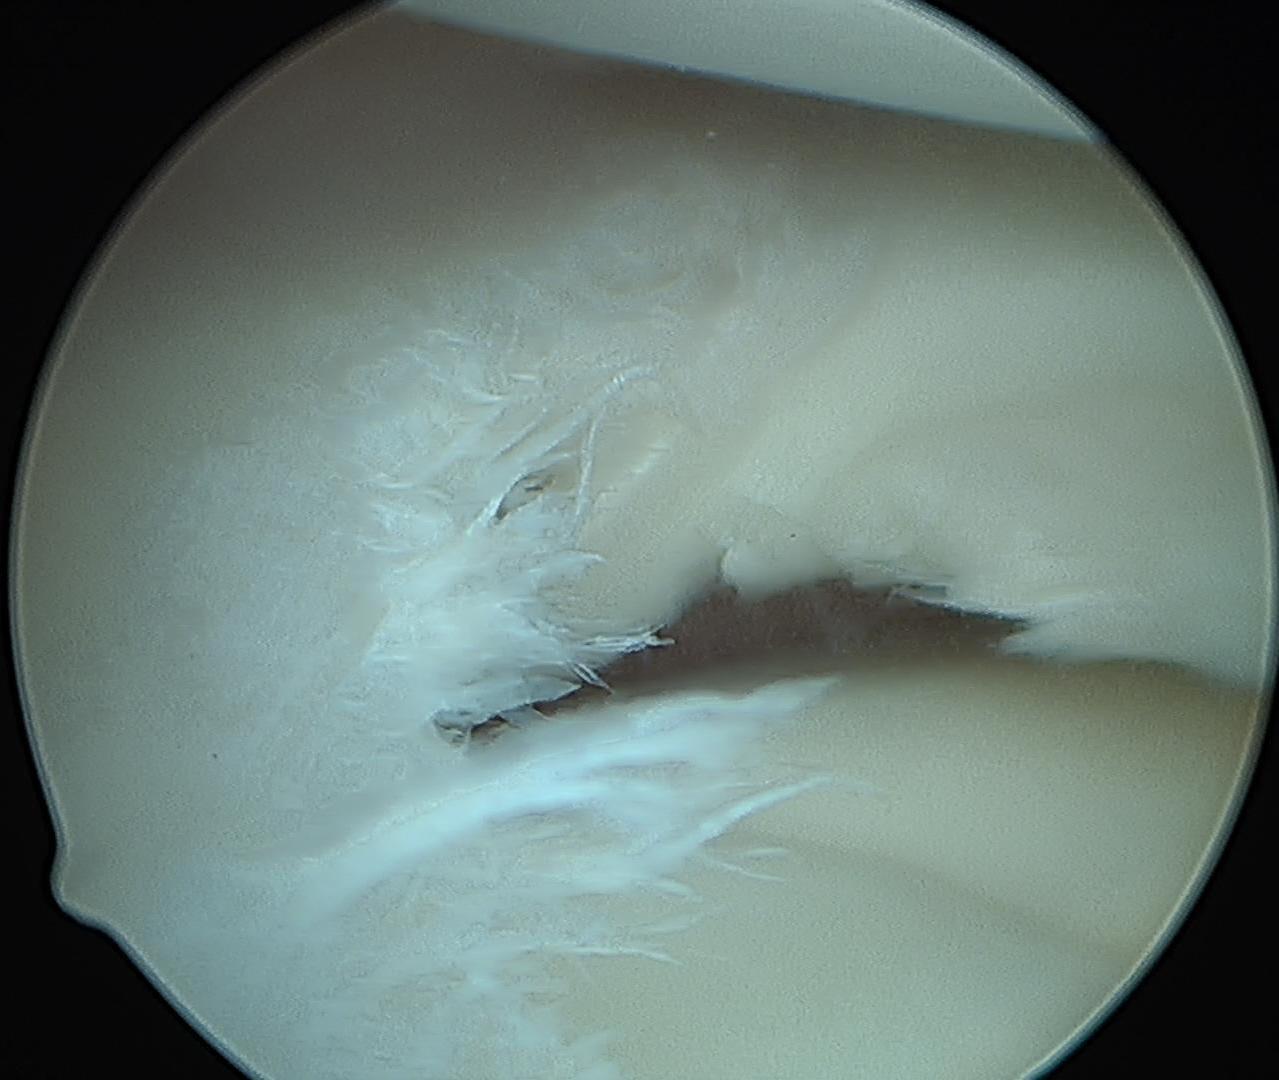
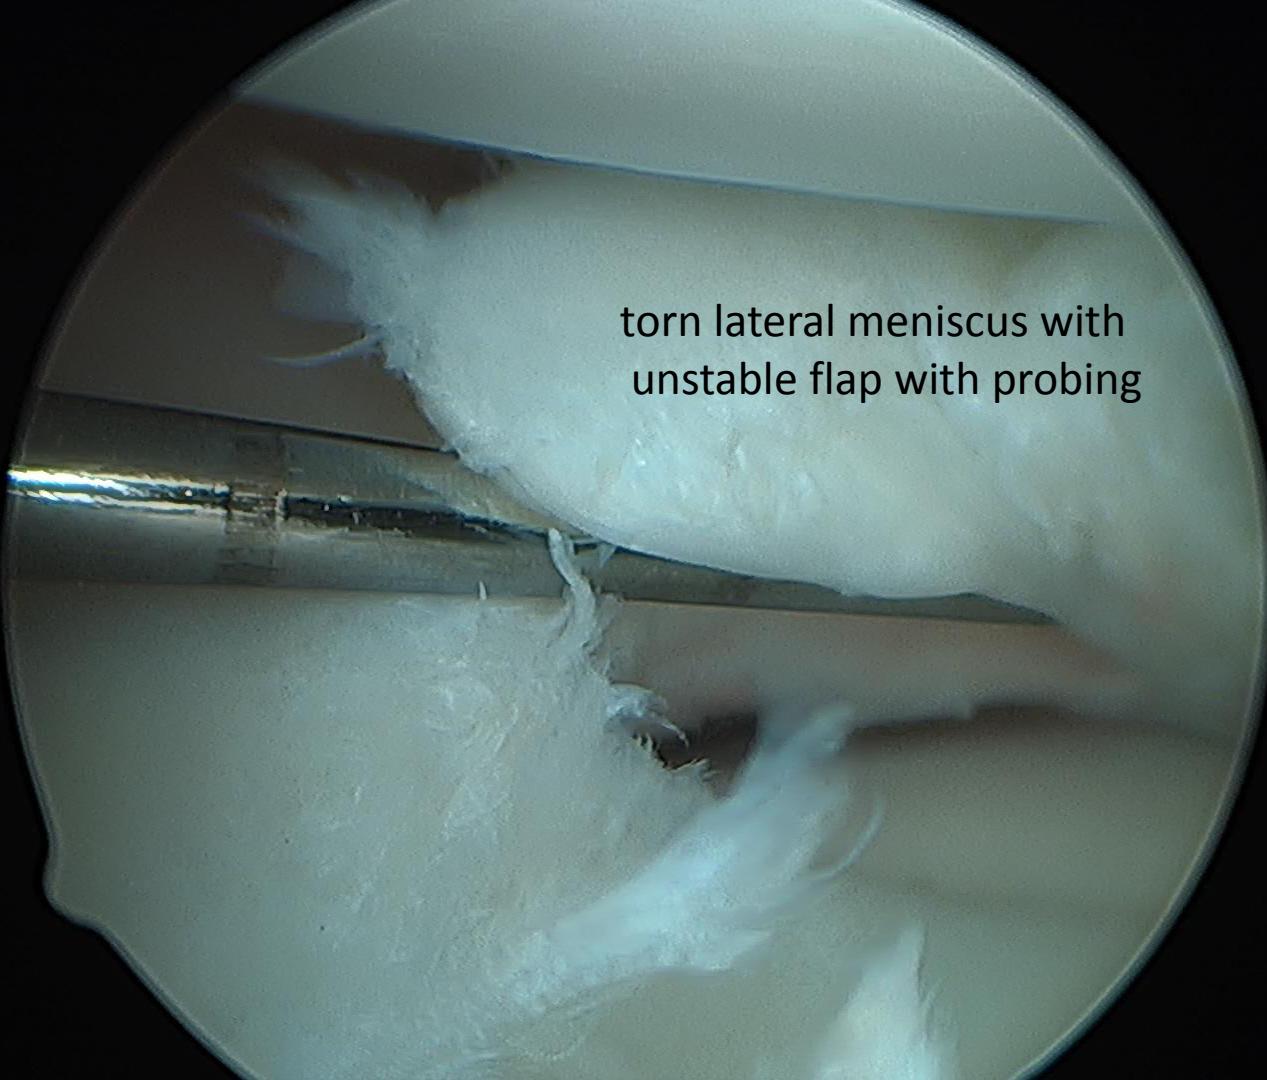
A circular arthroscopic image showing the interior of a joint. A torn piece of meniscus tissue is visible, appearing as a white, irregular flap within the darker, cartilaginous surface of the joint.

torn lateral meniscus with
unstable flap with probing
